# Factory Grade PP Repair Products

Polypropylene-based coating repair products for corrosion protection

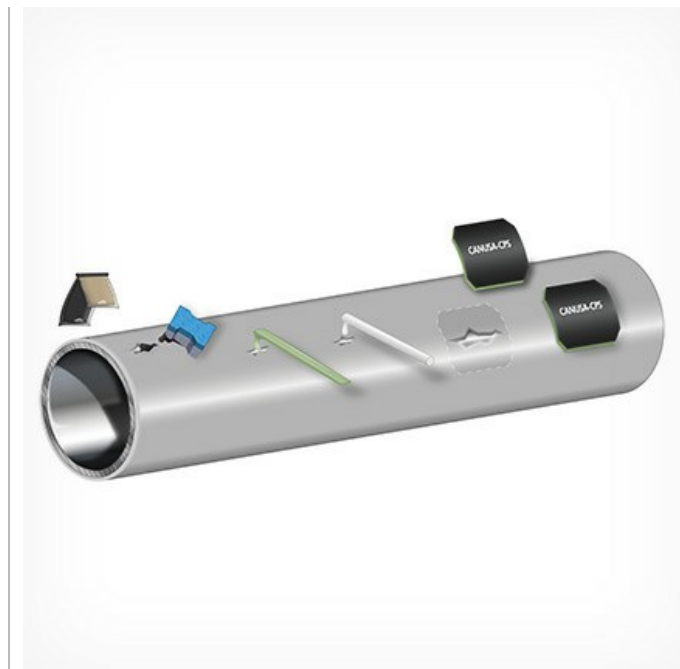
The polypropylene repair patch has been uniquely designed to be fully compatible with the polypropylene pipeline coating. The melt stick and the adhesive filler are also made from polypropylene for maximum compatibility. These aspects ensure compatibility throughout the range of Canusa products offered.
